PRESSURE INSPECTION SUMMARY REPORT

API 510 Inspection of Pressure Vessel

V1-R3 ACCUMULATOR

Report No : LEADS-23-03-API-07 R1

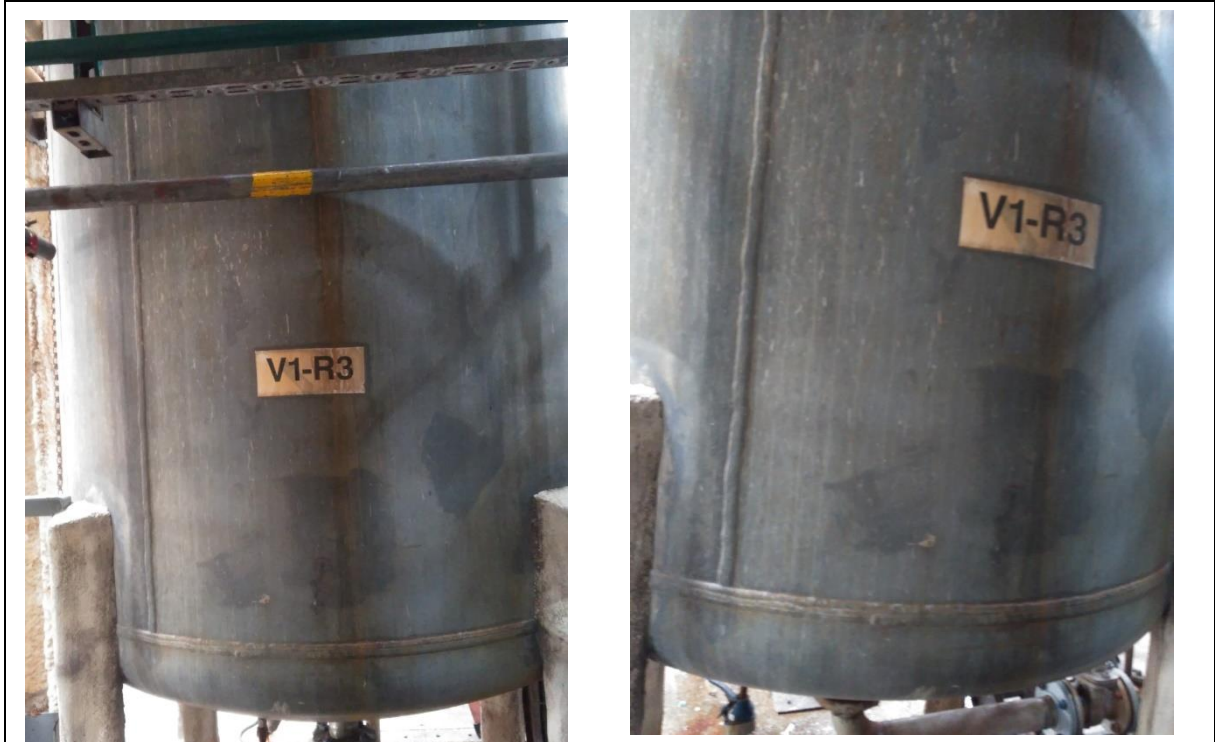
Photo 2: General view of V1-R3. In satisfactory condition.

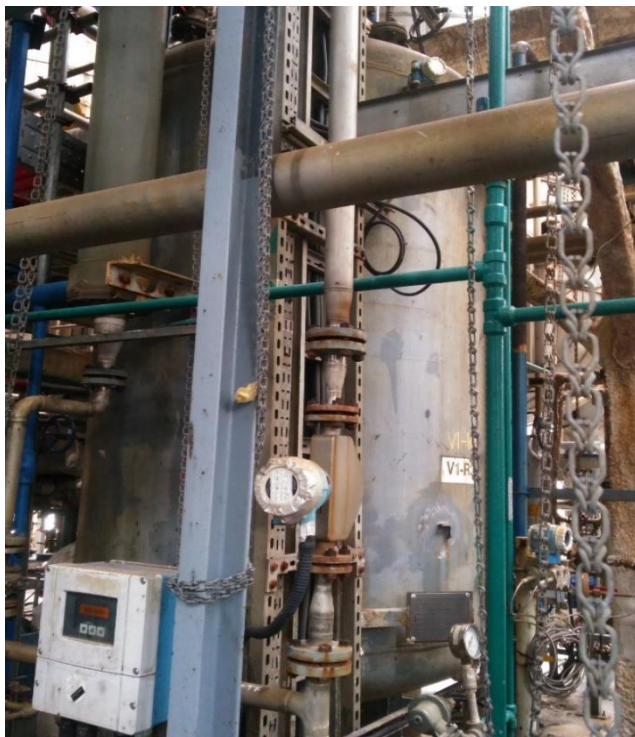
Photo 3: V1-R3 External view. In satisfactory condition.

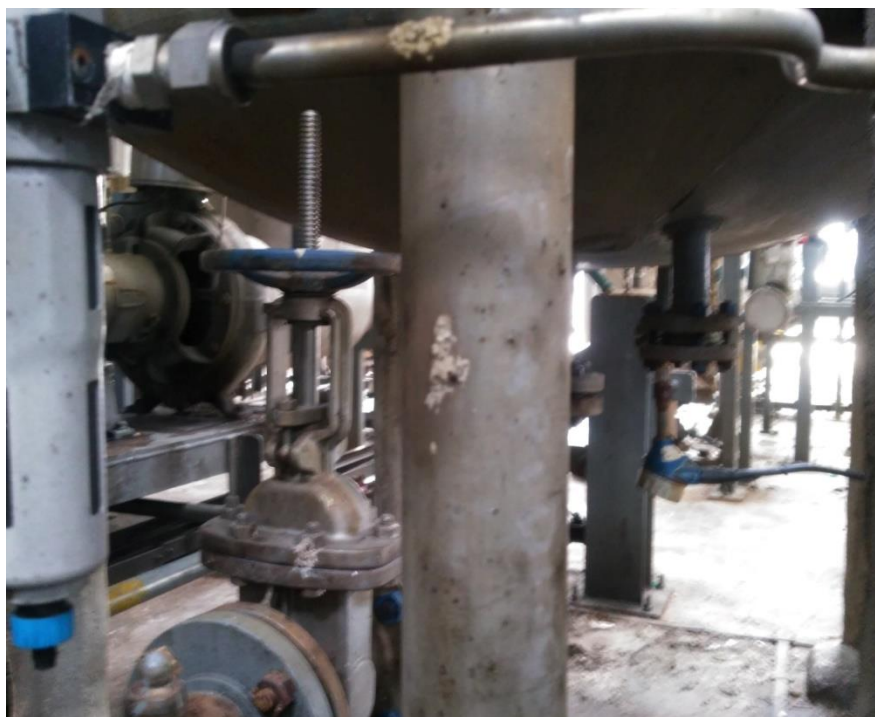
Photo 4: Column support and earthing was noted in satisfactory condition

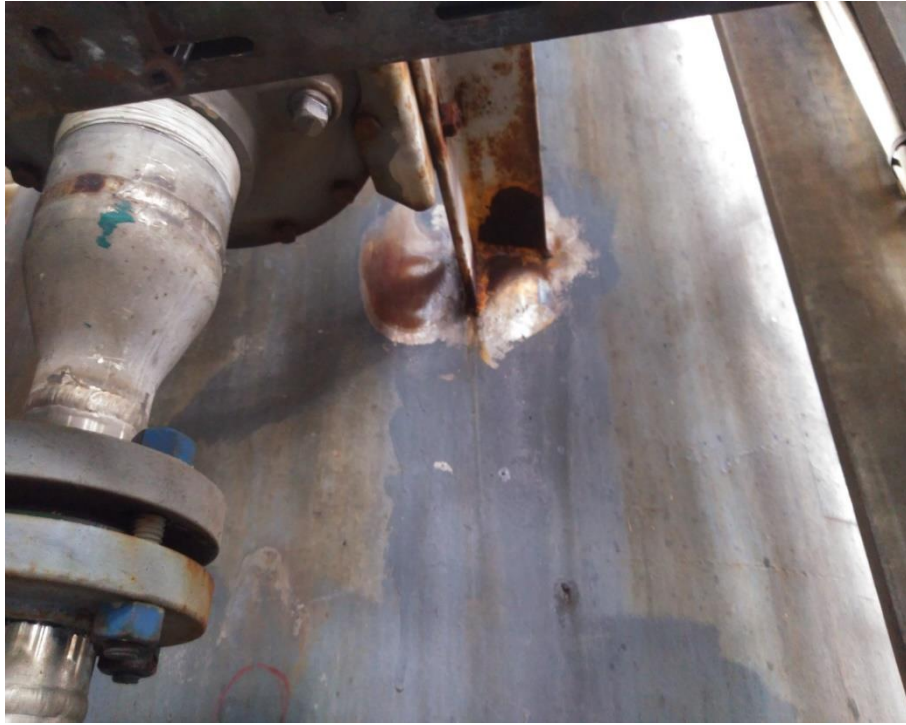
Photo 5: Pipe supports were directly welded to the shell and in satisfactory condition

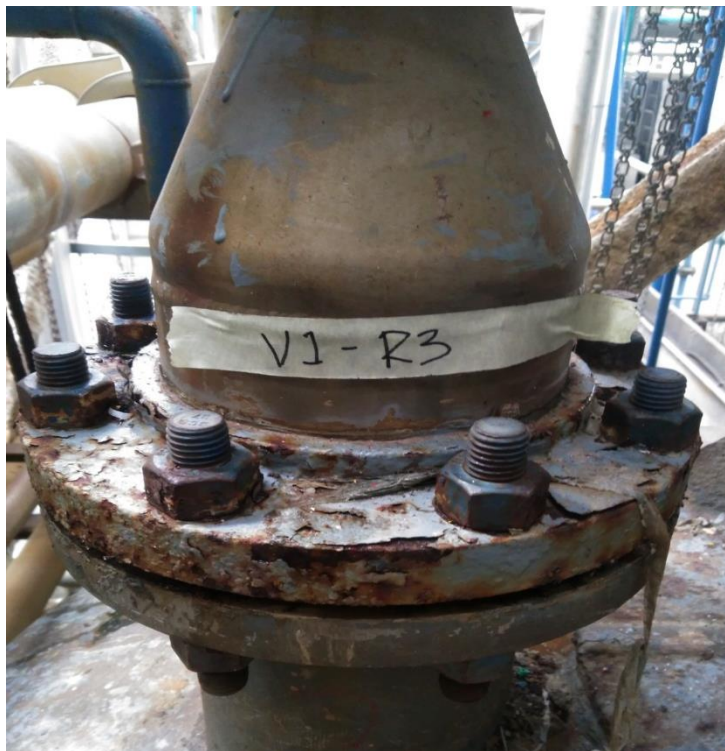
Photo 6: Top dish head nozzle was observed with minor rust.

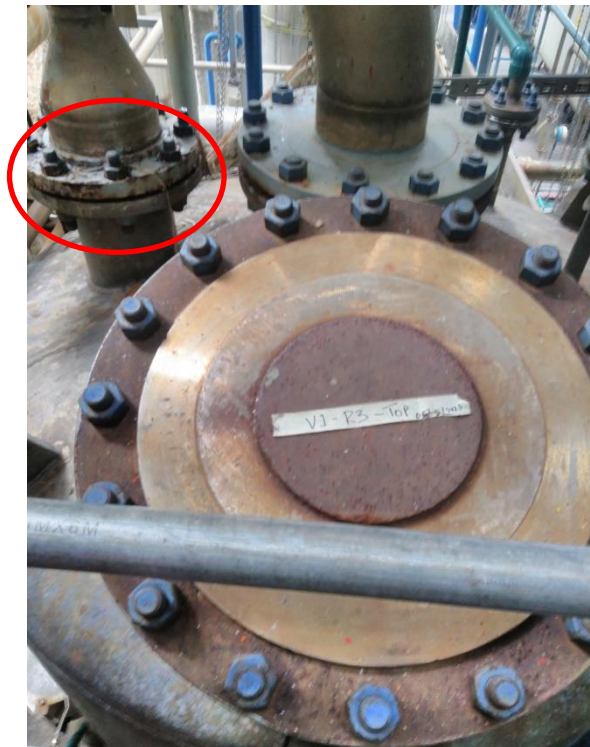
- Top dish head outer flange was observed with minor corrosion.
- Top dish head one of the Lifting lugs and nearby channel head is found with minor corrosion and algae from the water droplets.
- Top side pipe's insulation was damaged.

Photo 8: Top view of nozzle head. Flange was observed paint failure and lifting lug & nearby top dish head was observed with minor corrosion and algae.

Mandatory Repairs Preceding Return To Service	
I.1	None
Non-Mandatory Recommended Repairs Preceding Return-To-Service	
II.1	None
Future Non-Mandatory Recommended Repairs	
III.1	Recommend to do surface preparation and painting of the top dish head outer flanges
III.2	Recommend to clean and touchup paint the top dish head one of the Lifting lug and nearby head
III.3	Recommend to fix the insulation damage at the top side pipe connection.
Recurring Maintenance Recommendations	
IV.1	Let the fire and safety systems be checked on an annular base by a safety engineer.
IV.2	Perform proper housekeeping on a regular base.
IV.3	Perform visual and UT inspections as per Inspection Interval Recommendation.

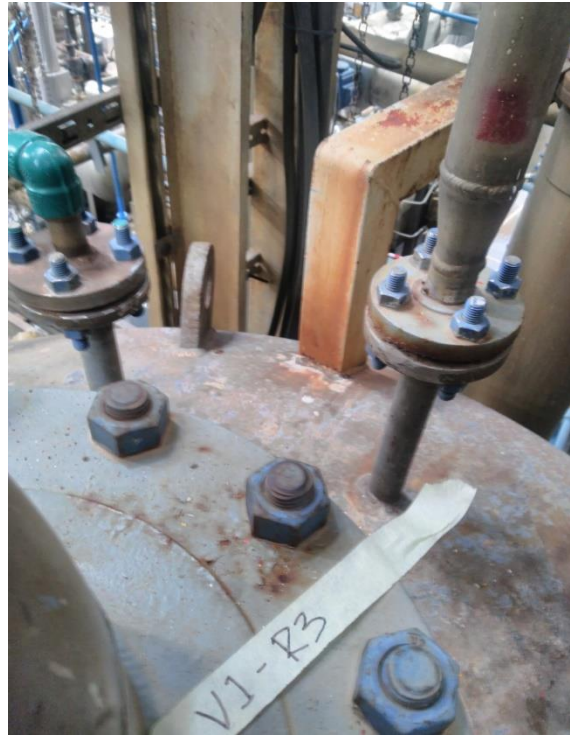
Photo 9: Shell nozzle were observed in satisfactory condition

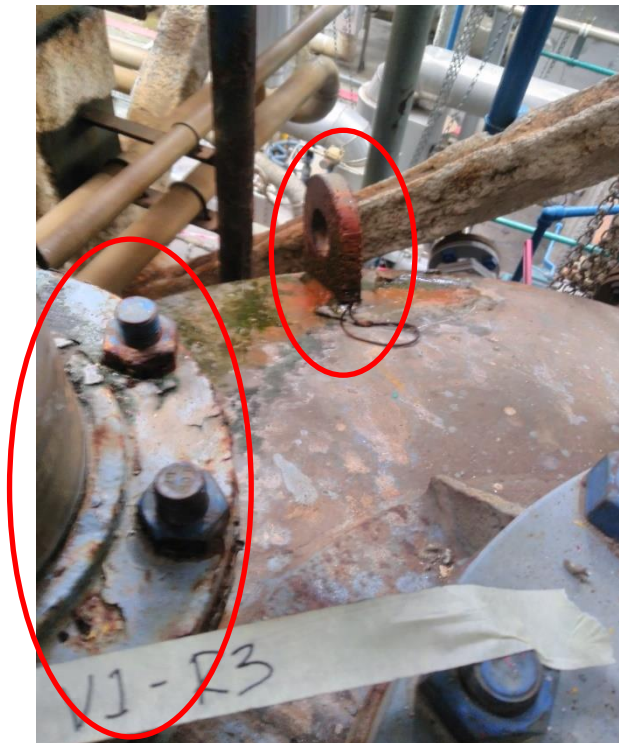
Photo 10: Top view of nozzle head. Flange was observed paint failure and lifting lug & nearby top dish head was observed with minor corrosion and algae.

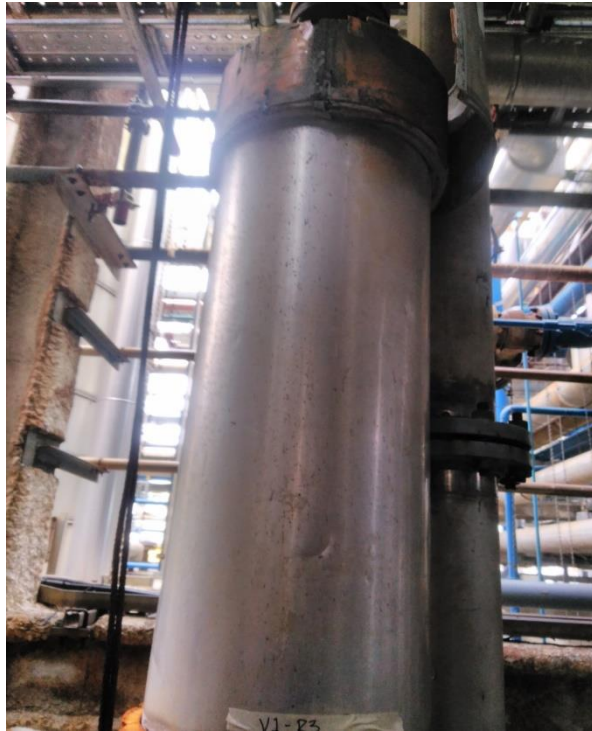
Photo 11: Top dish head pipe insulation was damaged.

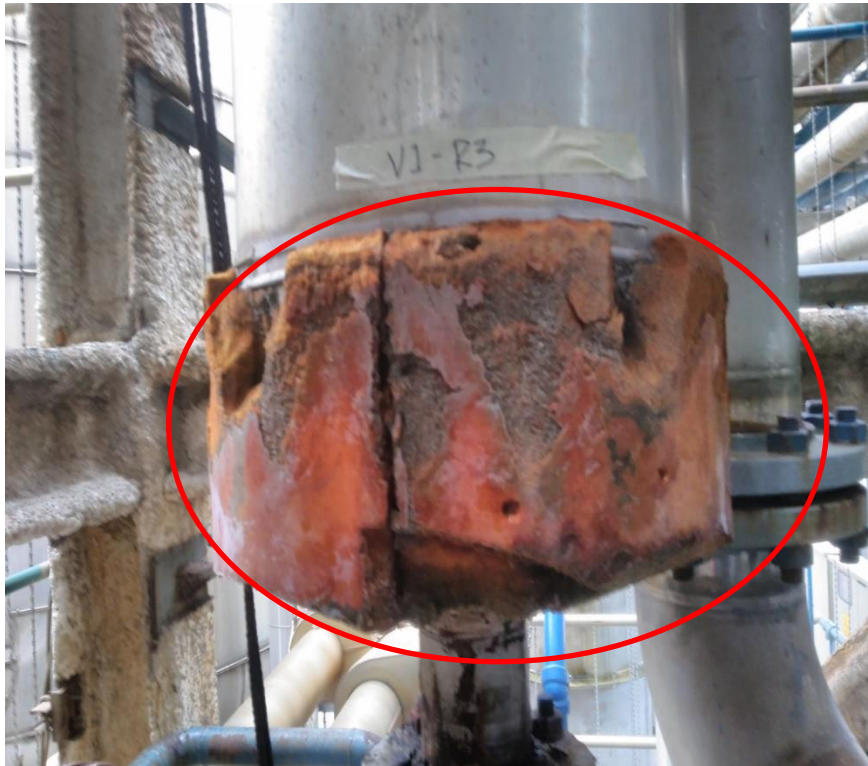
Photo 12: Top dish head pipe insulation was damaged.
