PRESSURE INSPECTION SUMMARY REPORT

API 510 Inspection of Pressure Vessel

R3 REACTOR

Report No : LEADS-23-03-API-08 R1

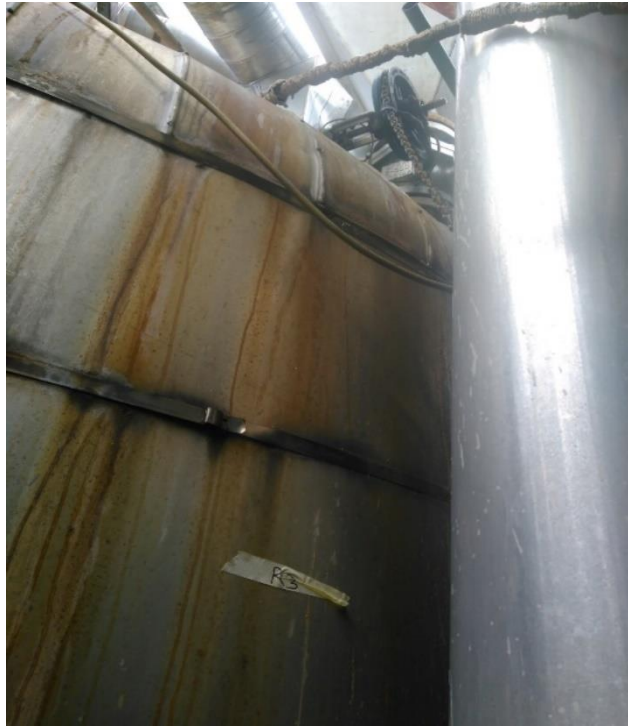
Photo 1: External view R3, in satisfactory condition

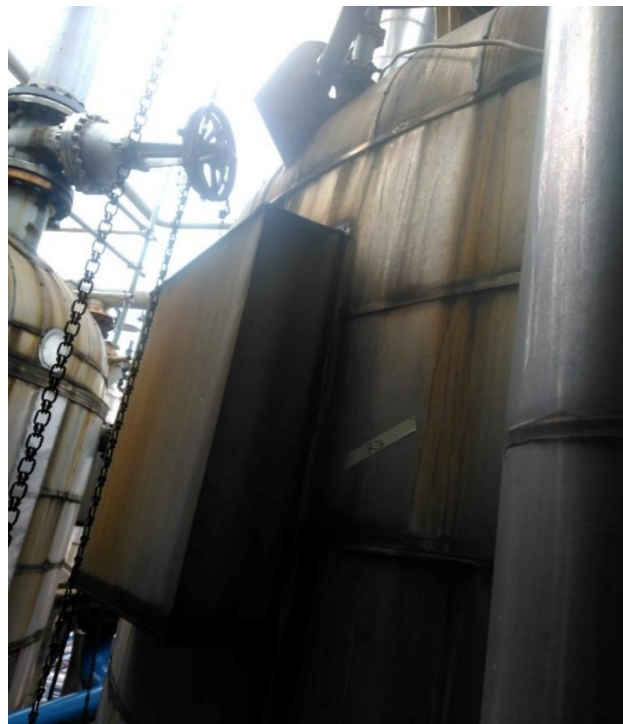
Photo 2: External view R3, in satisfactory condition

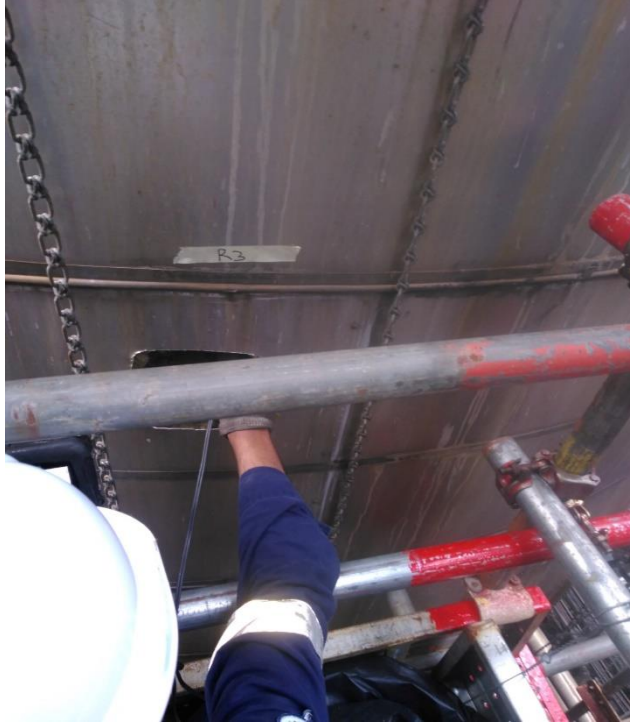
Photo 3: UTG measurement in Shell plates/ water jacket was done. External insulation was in satisfactory condition.

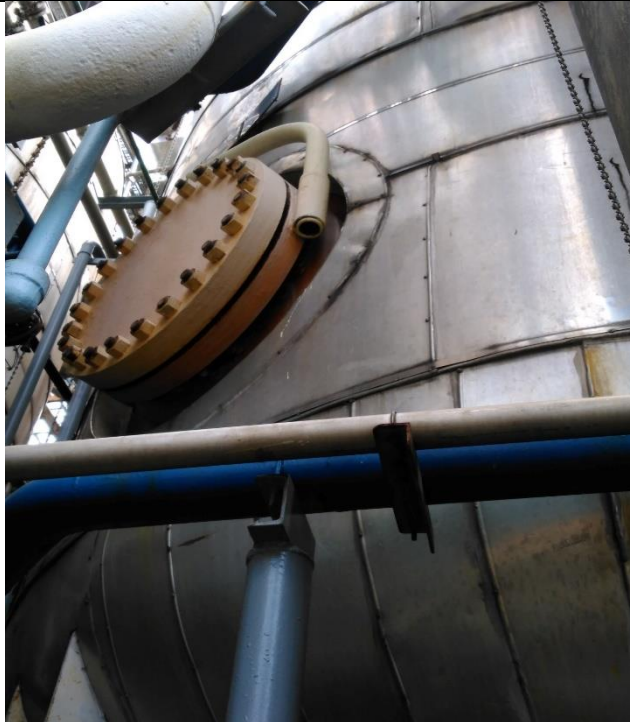
Photo 4: Manhole was in satisfactory condition

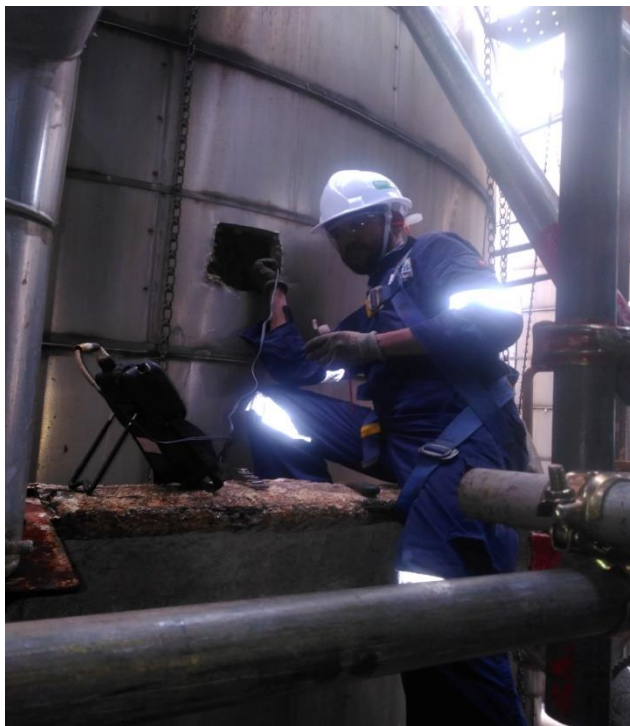
Photo 5: UTG measurement in Shell plates/ water jacket was done. External insulation was in satisfactory condition.

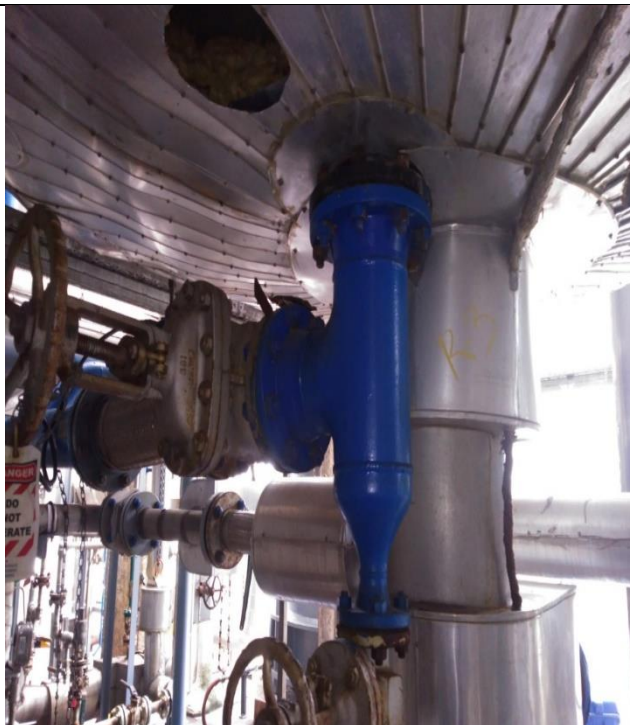
Photo 6: Nozzles was observed in satisfactory condition

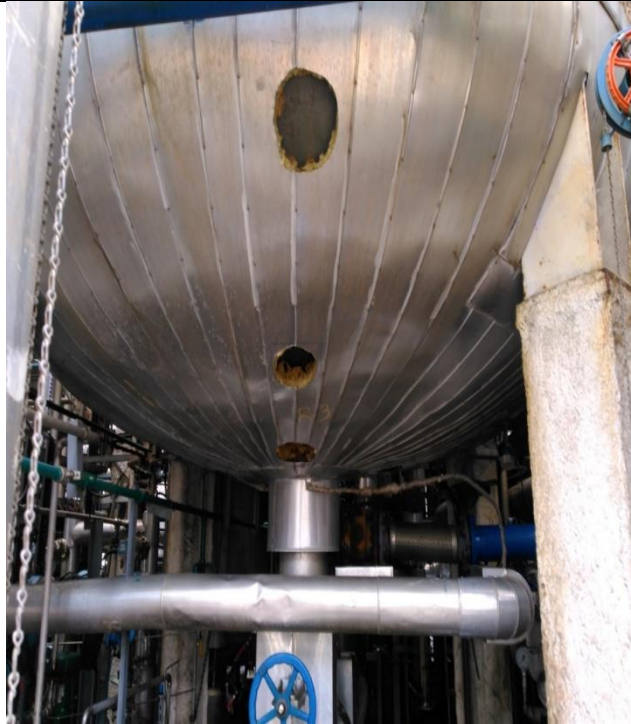
Photo 7: Bottom dish head/ water jacket was observed in satisfactory condition

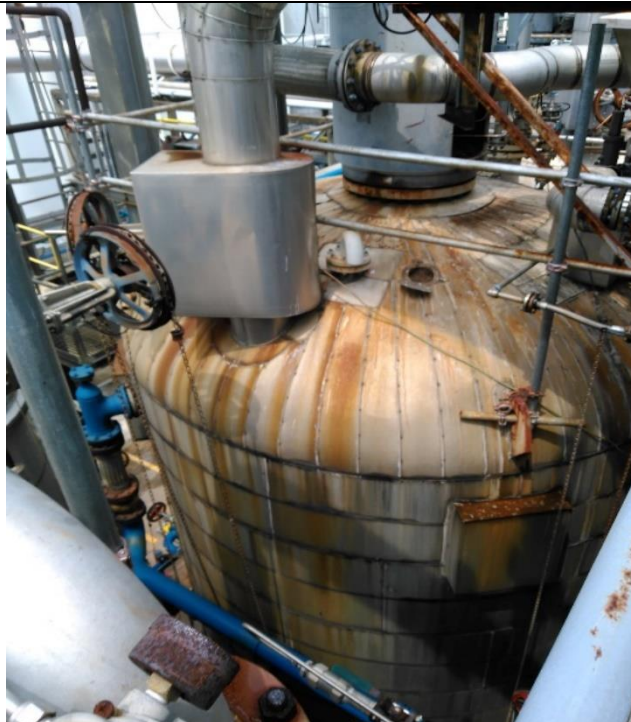
Photo 8: Insulation was in satisfactory condition with stain marks.

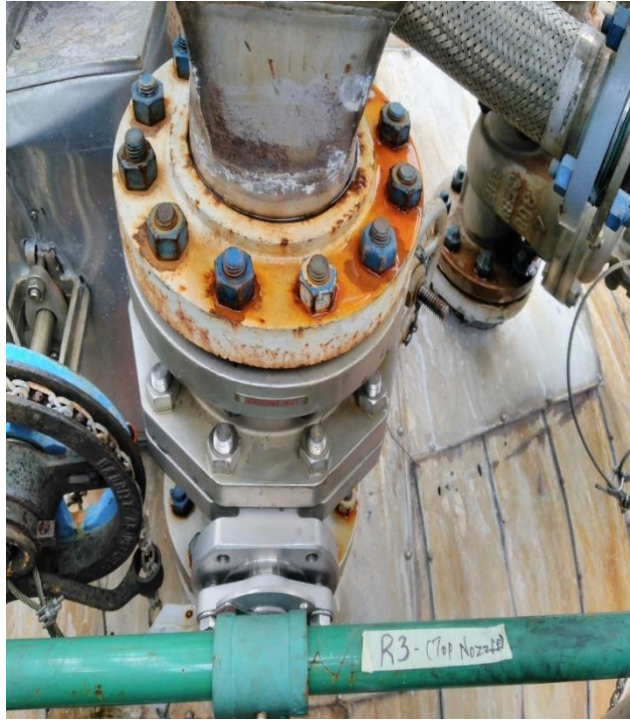
Photo 9: Top Shell nozzle was observed in satisfactory condition. Minor rust was observed on flange area.

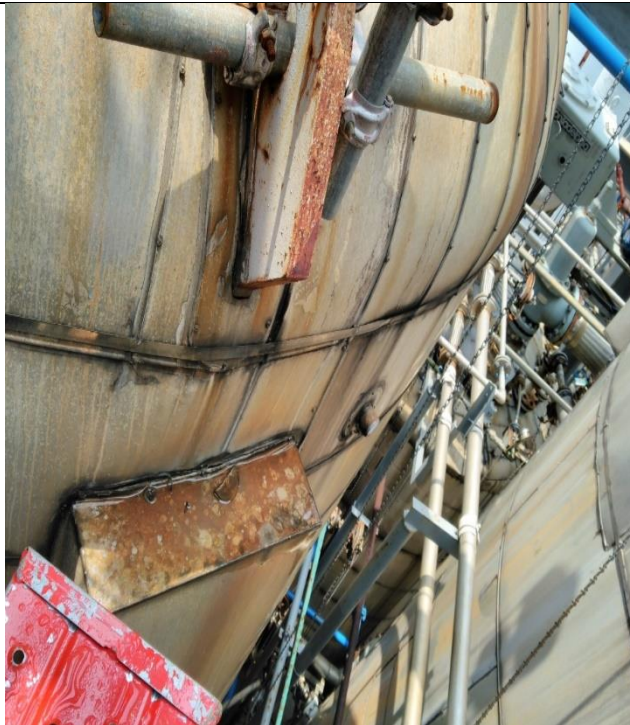
Photo 10: Support Bracket and Insulated area was observed with minor rust.

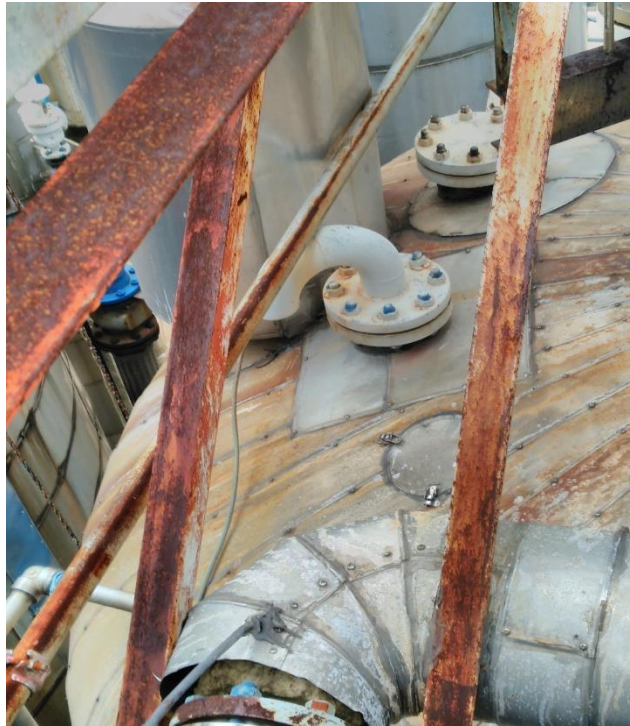
Photo 11: Top shell nozzle was observed with satisfactory condition.

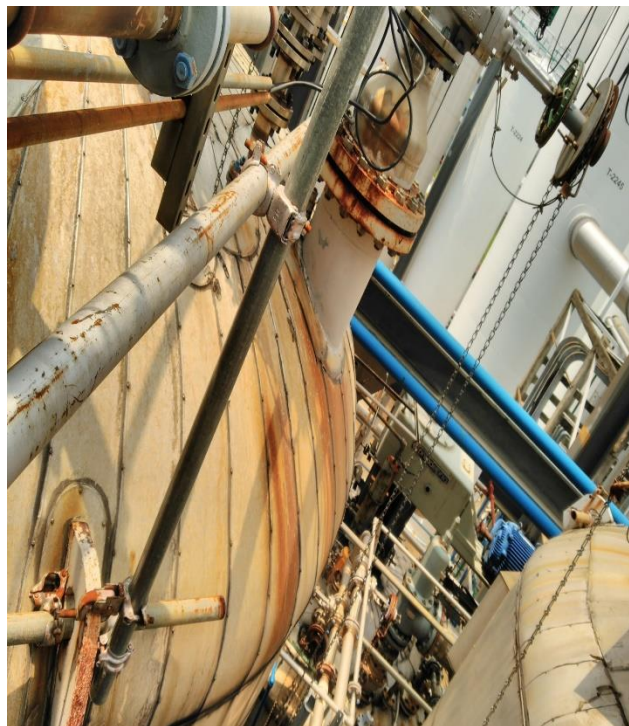
Photo 12: Top Shell nozzle was observed in satisfactory condition. Minor rust was observed on flange area.

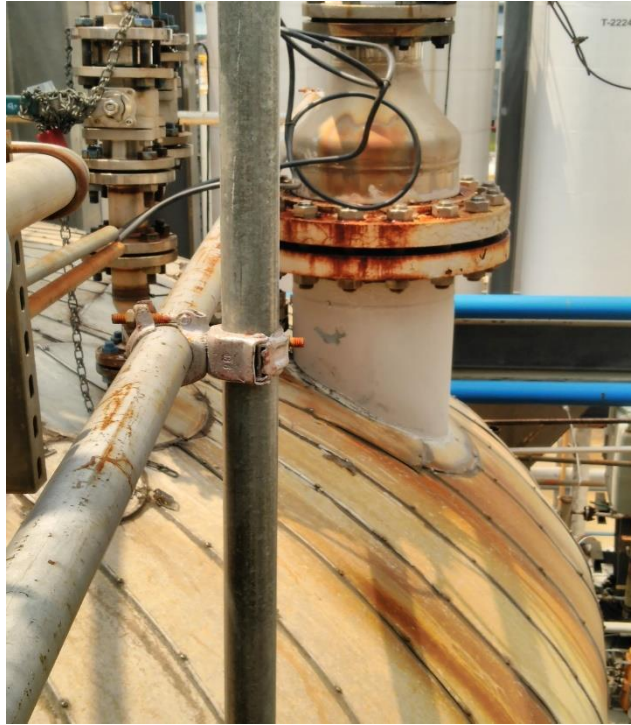
Photo 13: Top Shell nozzle was observed in satisfactory condition. Minor rust was observed on flange area.

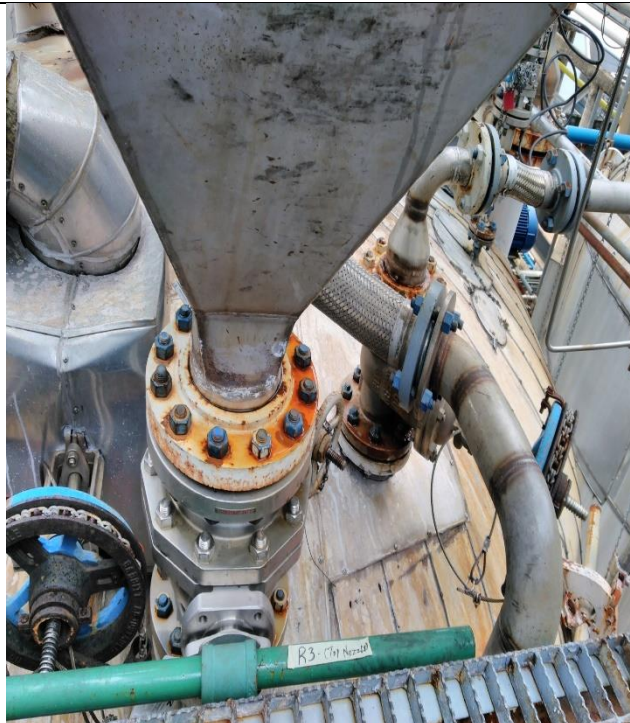
Photo 14: Top Shell nozzle was observed in satisfactory condition. Minor rust was observed on flange area.
