PRESSURE INSPECTION SUMMARY REPORT

API 510 Inspection of Pressure Vessel

E1-R3 EXCHANGER

Report No : LEADS-23-03-API-05

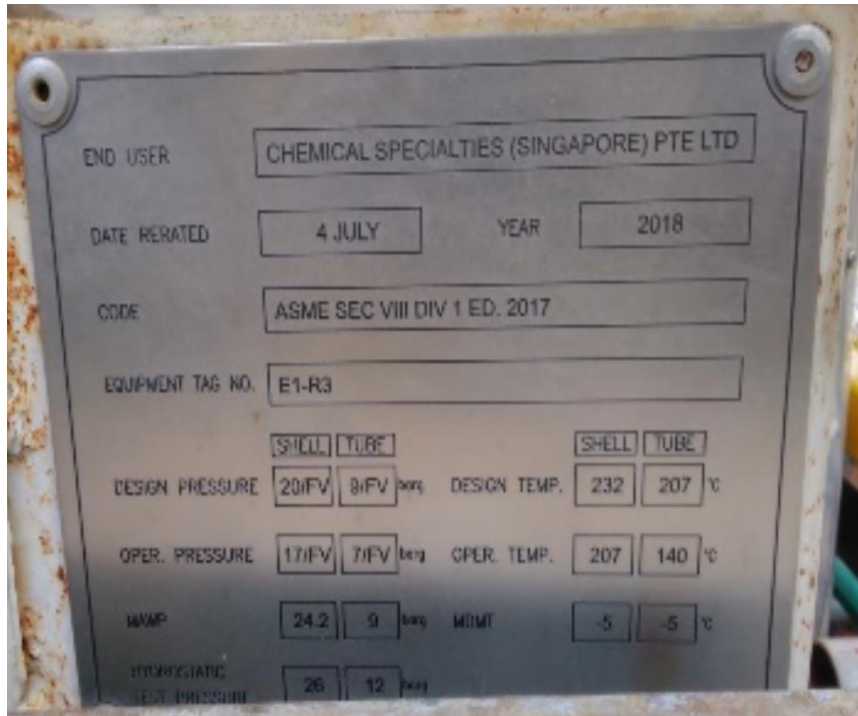
Photo 1: Name plate observed in satisfactory condition.

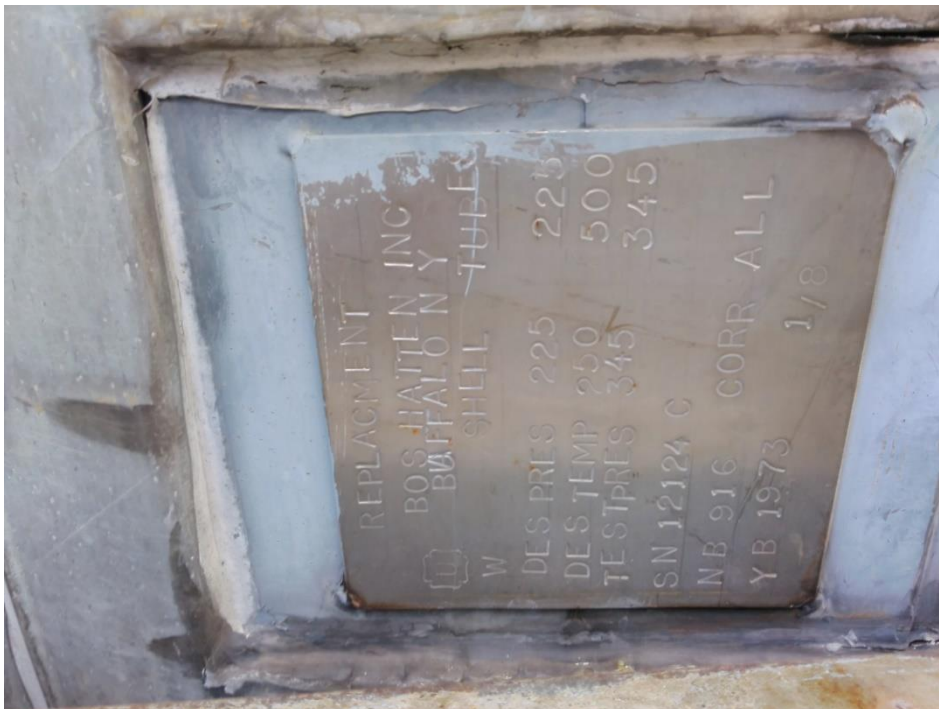
Photo 2: Design Identification plate was observed in satisfactory condition

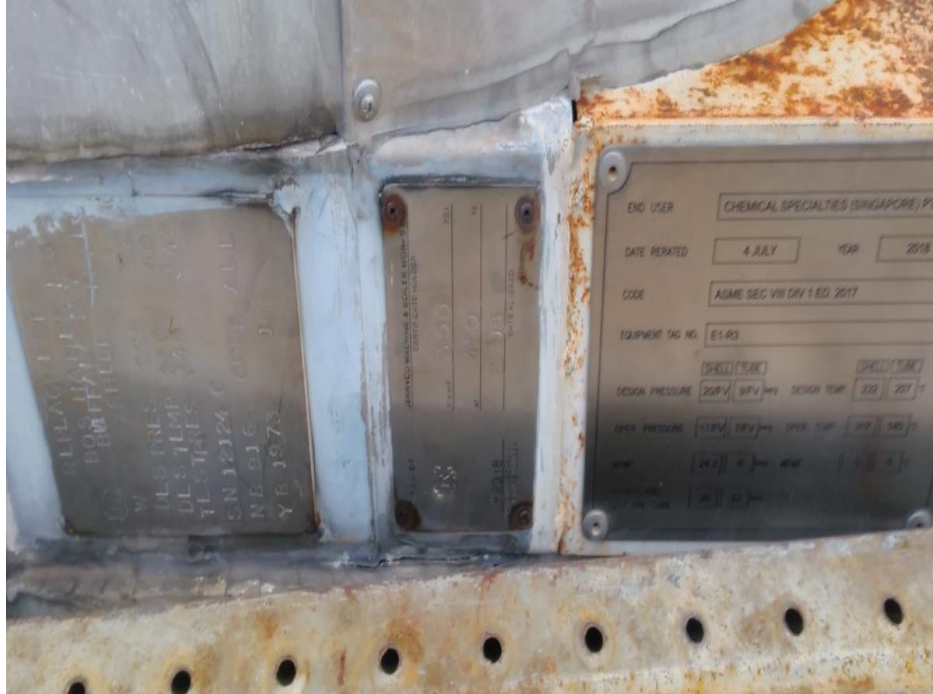
Photo 3: Tank identification plate was observed in satisfactory condition

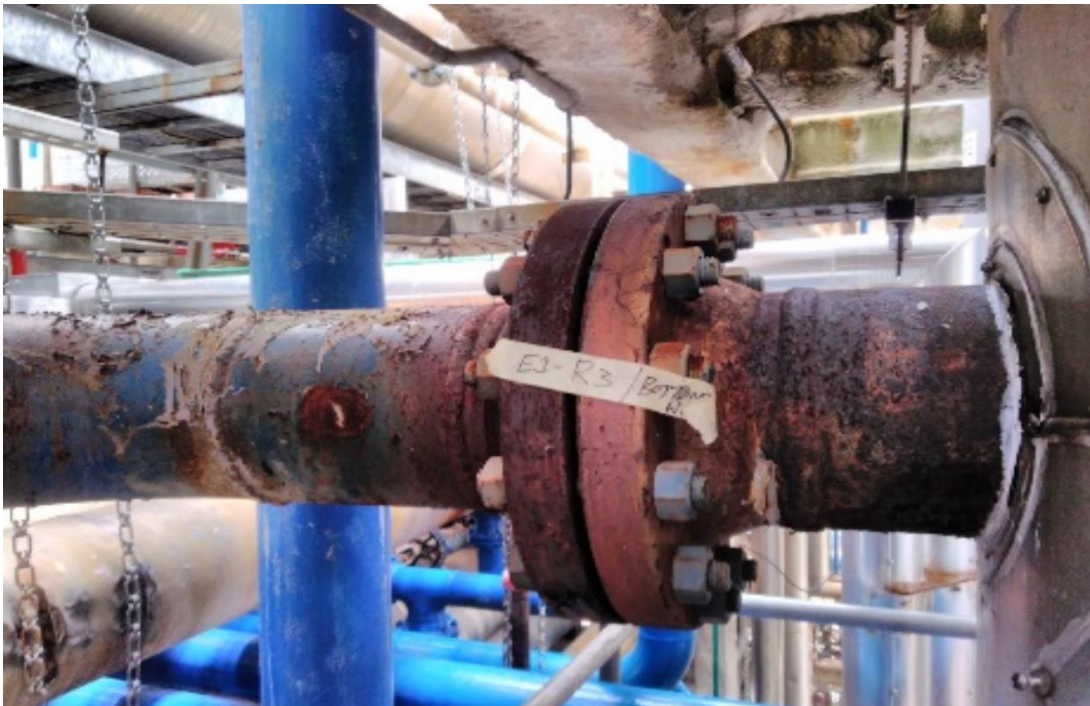
Photo 4: Bottom Shell nozzle were observed with minor corrosion

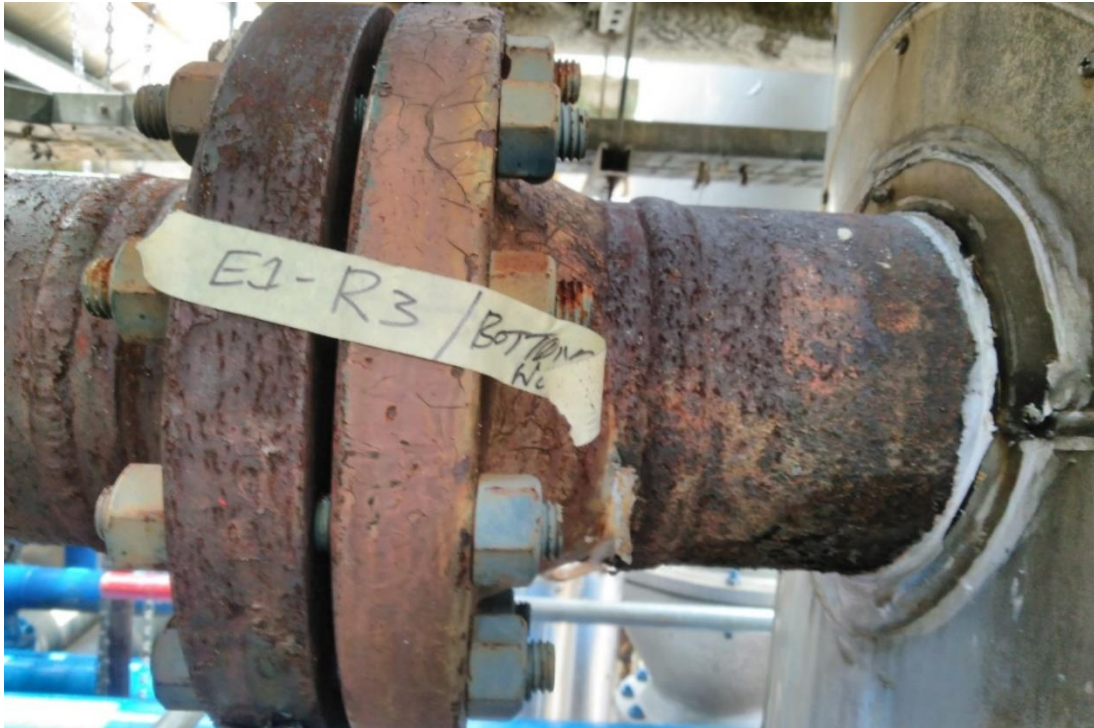
Photo 5: Bottom Shell nozzle were observed with minor corrosion

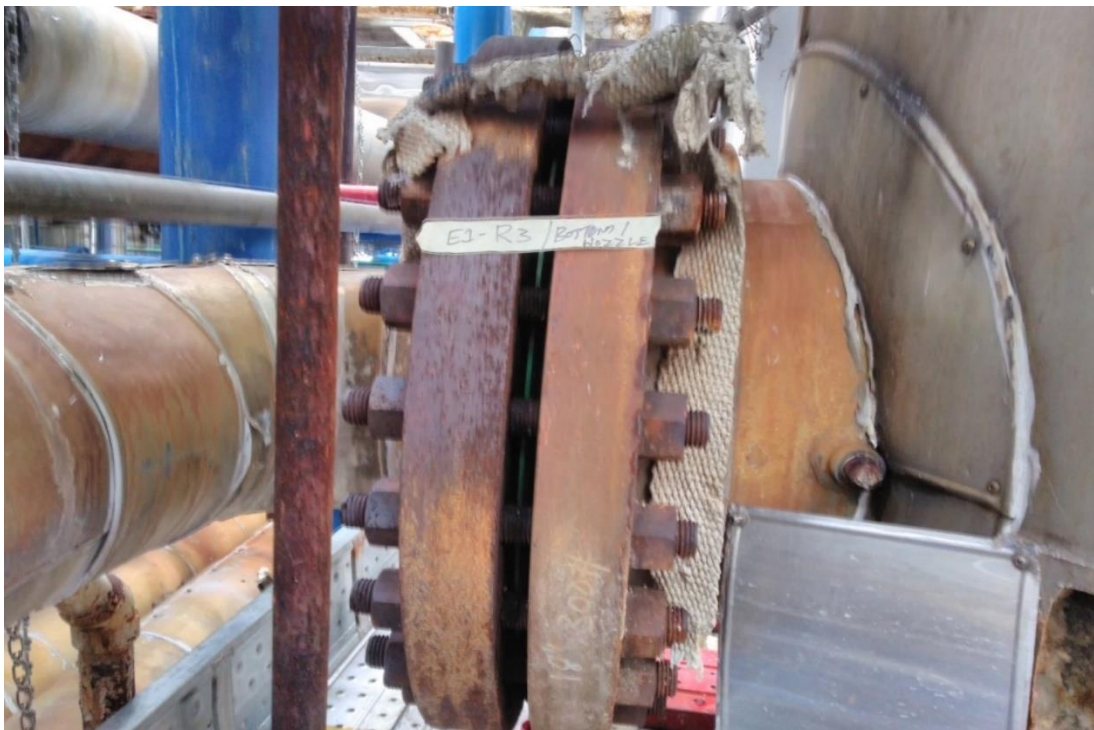
Photo 6: Bottom Shell nozzle were observed with minor rusting

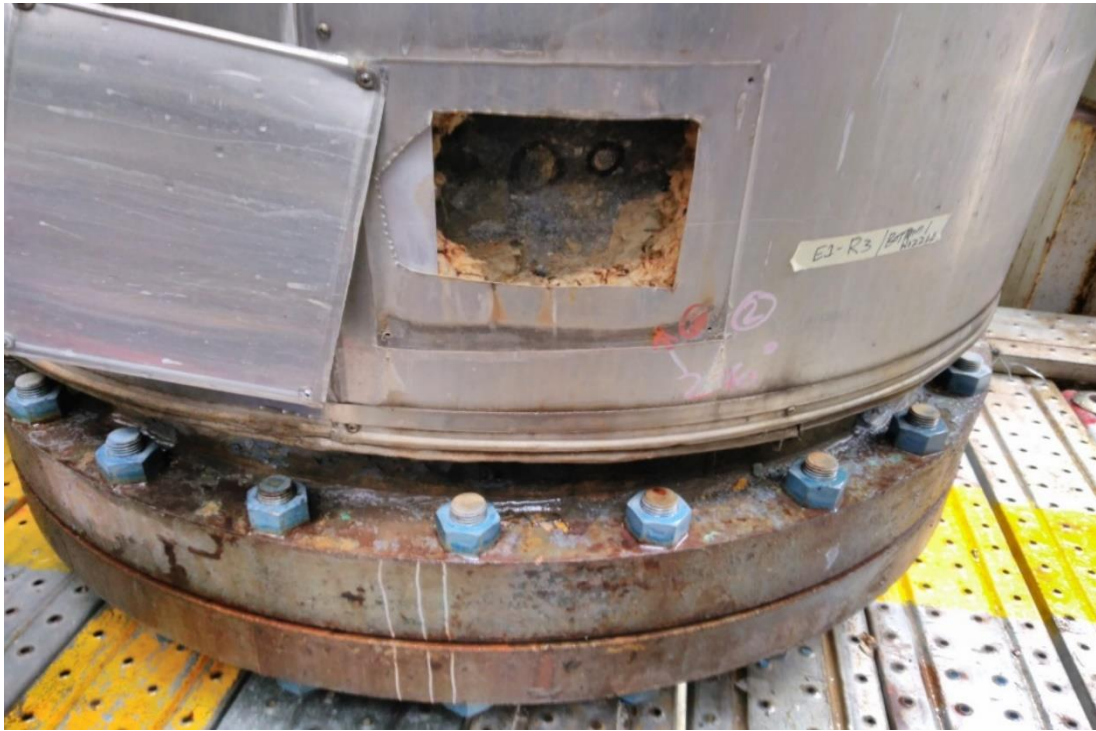
Photo 7: Bottom Shell was observed in satisfactory condition through the insulation window

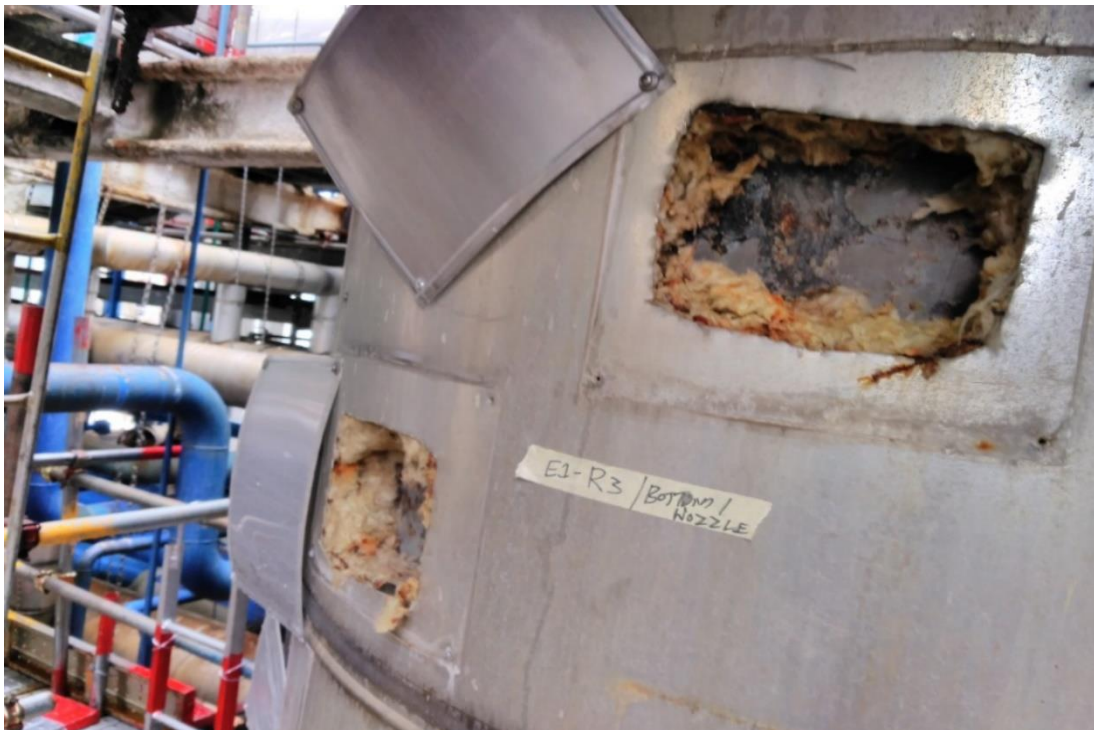
Photo 8: Bottom Shell was observed in satisfactory condition through the insulation window

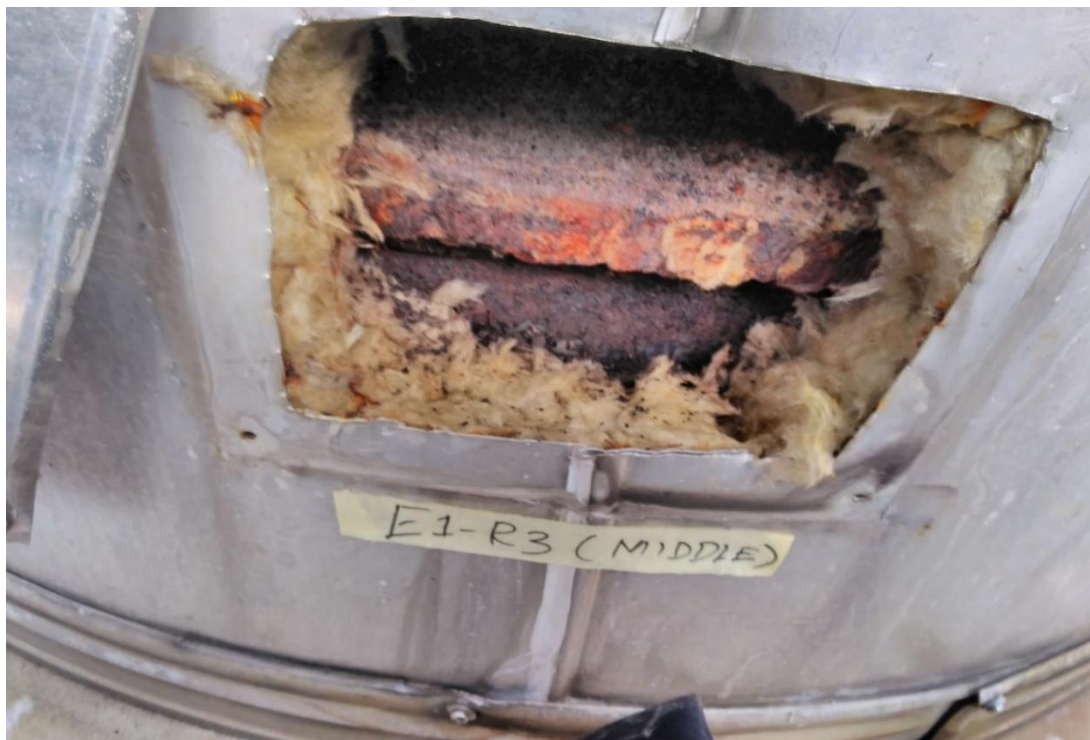
Photo 9: Middle Shell was observed with minor rust through the insulation window

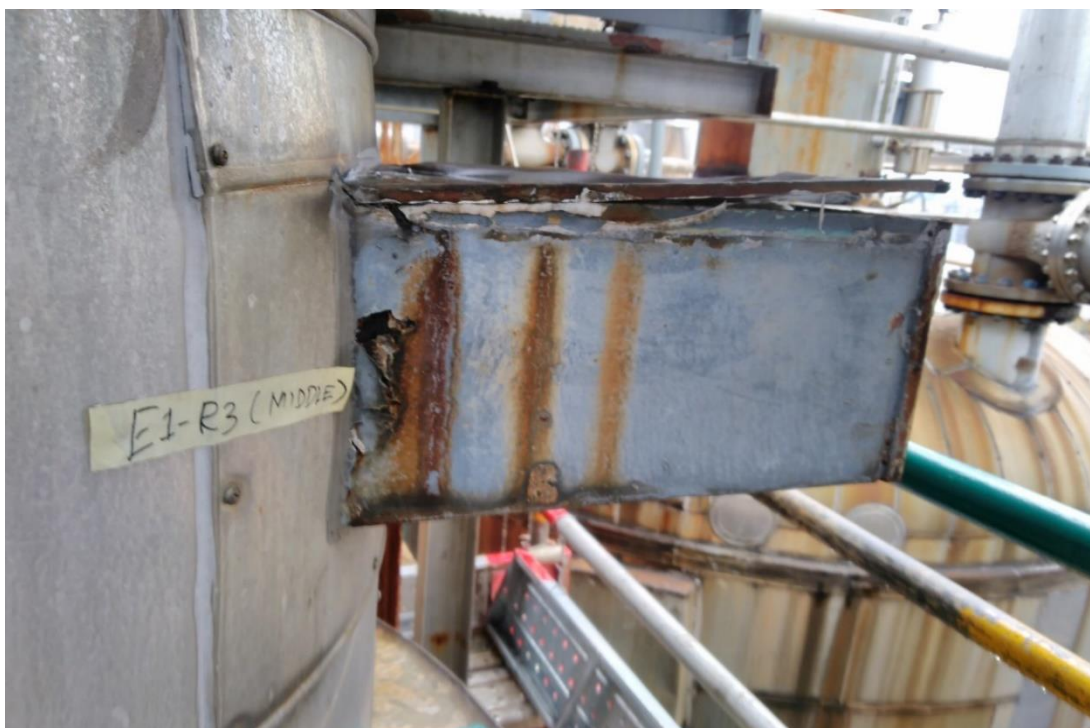
Photo 10: Support Bracket was noticed in damaged condition.

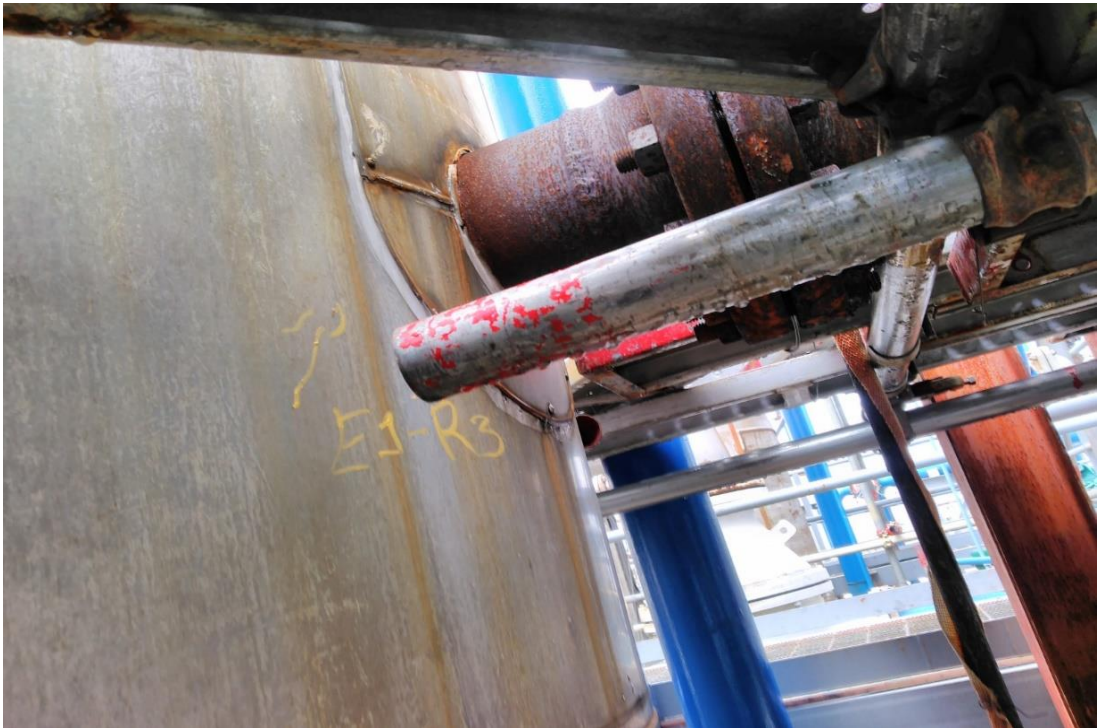
Photo 11: Shell Nozzle was observed with minor rust.

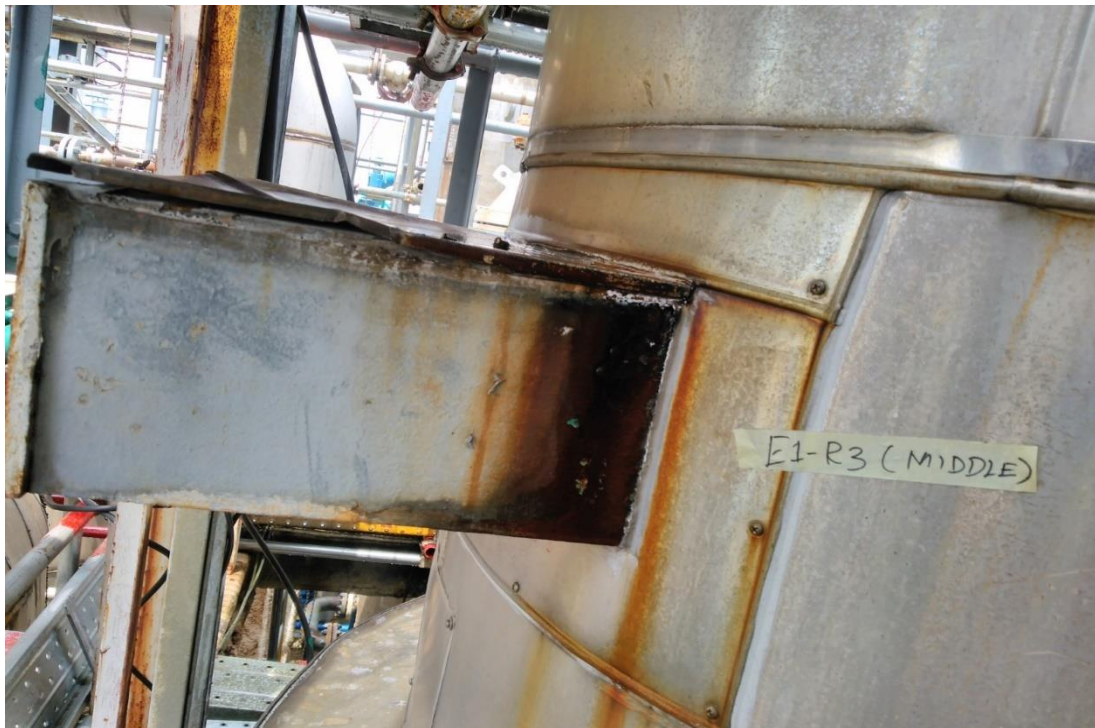
Photo 12: Support bracket was observed in satisfactory condition

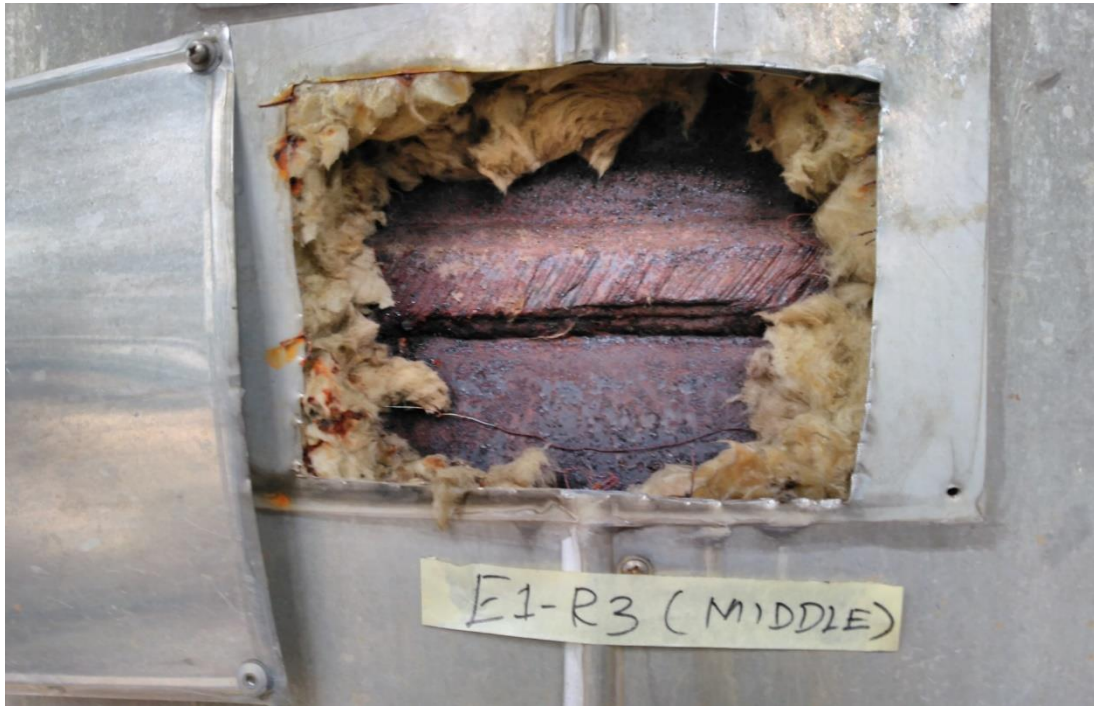
Photo 13: Middle Shell was observed with rust through the insulation window

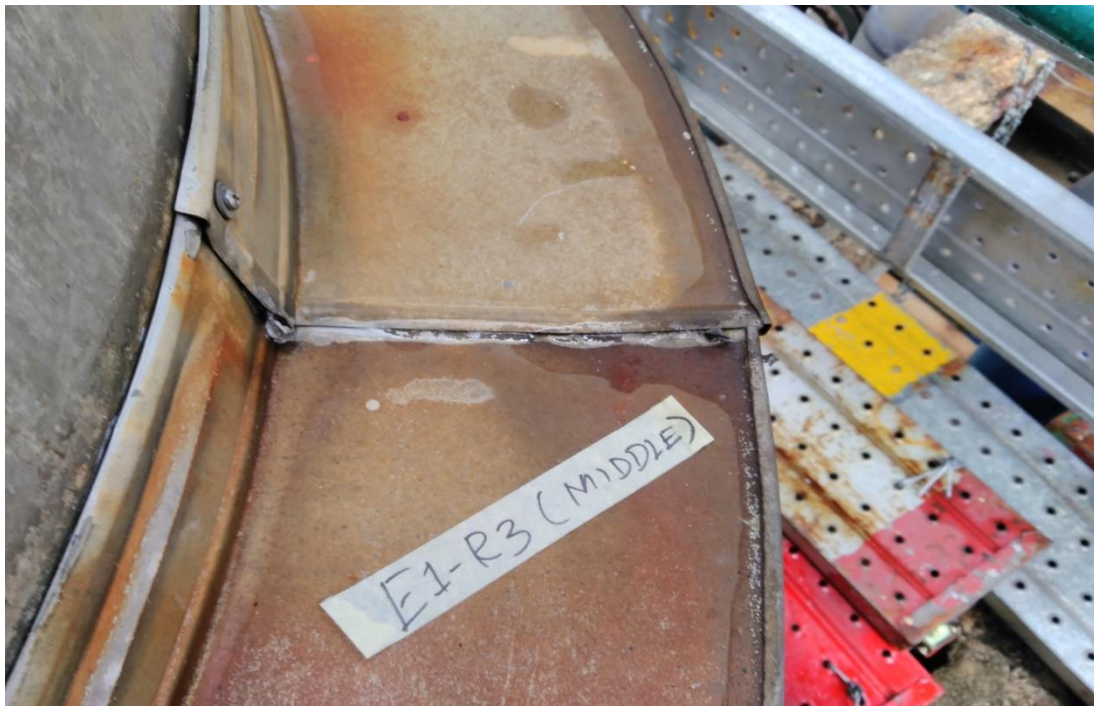
Photo 14: Flange attachment was in satisfactory condition

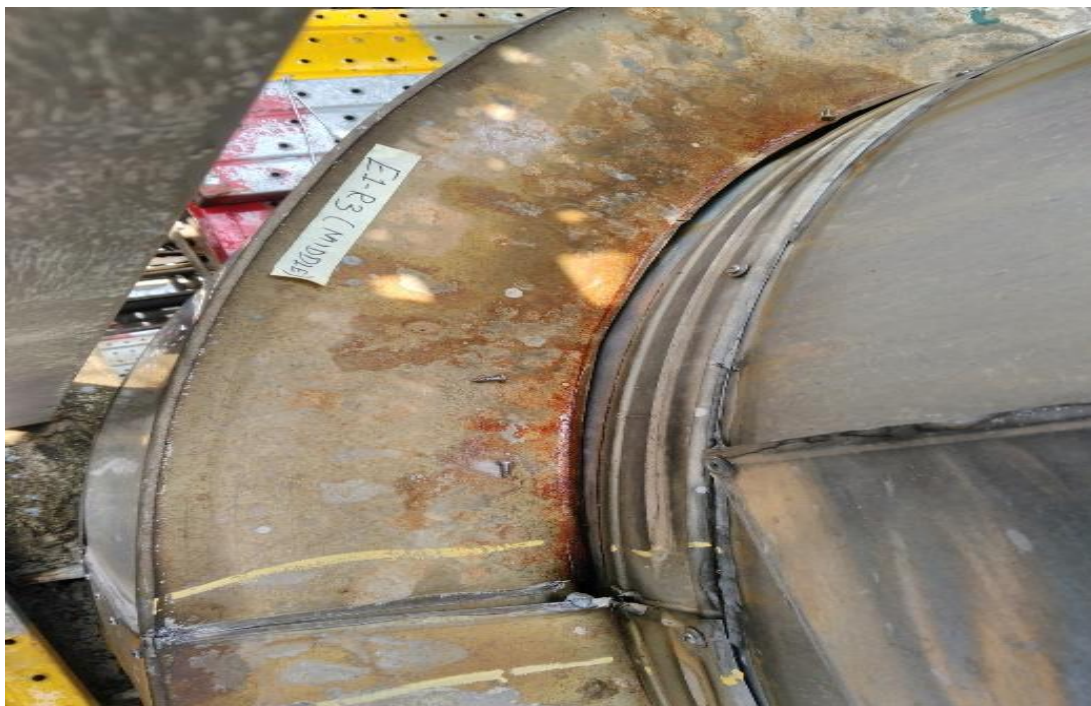
Photo 15: Flange attachment was in satisfactory condition

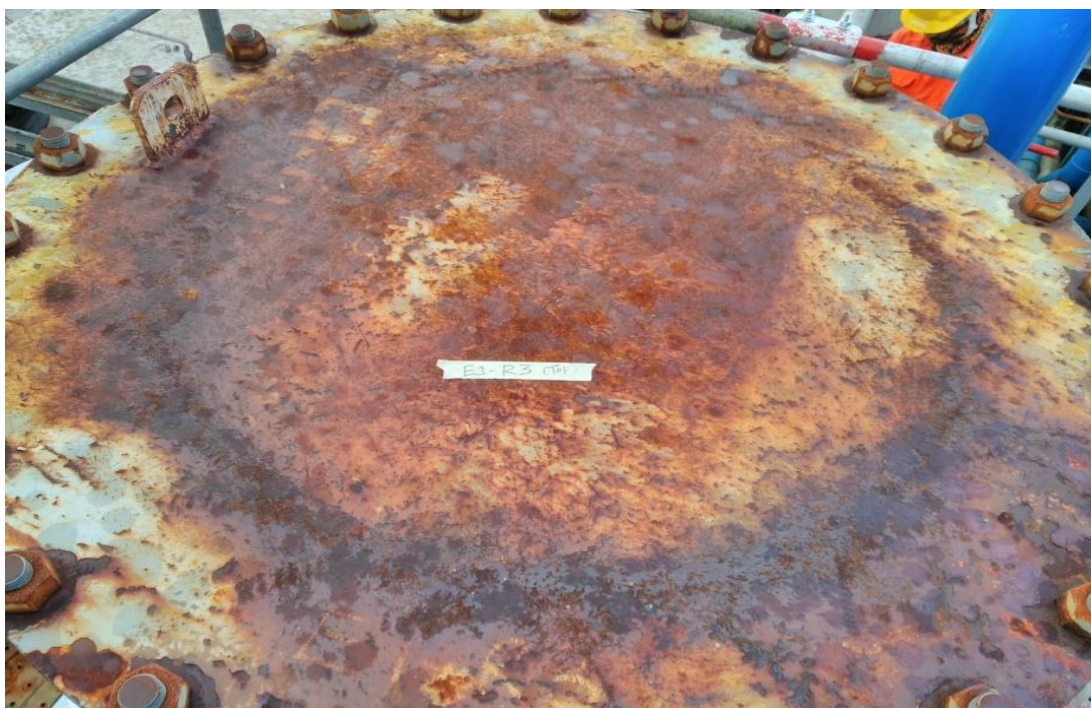
Photo 16: Top dish flange was observed with surface rust.

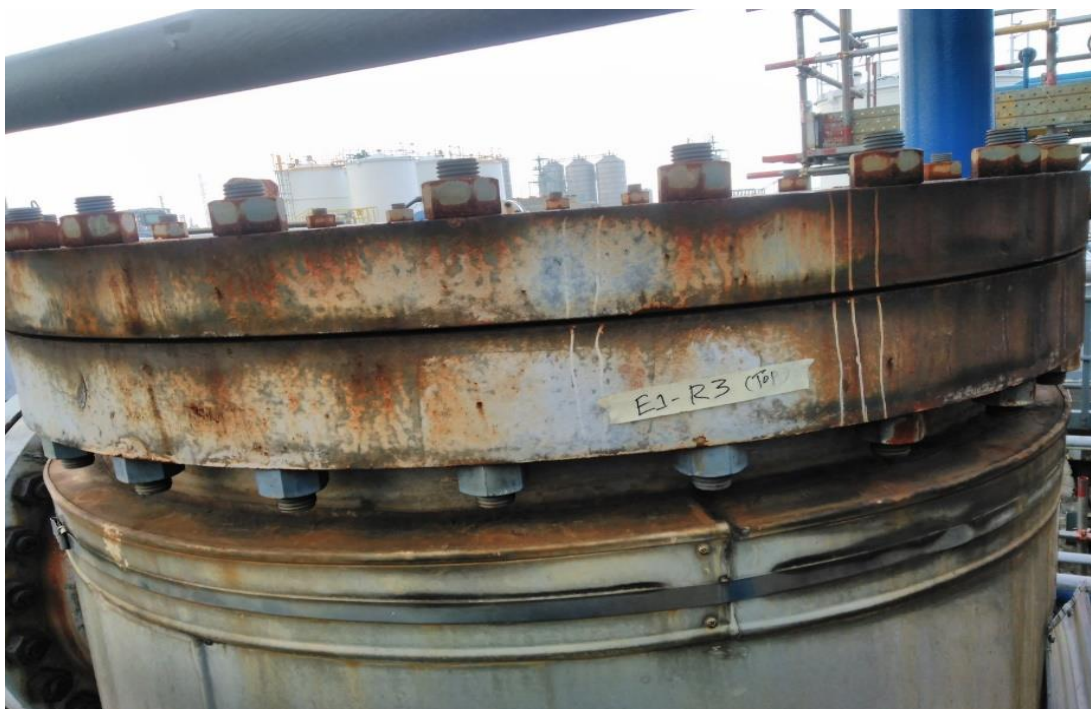
Photo 17: Top area Nozzle was observed in satisfactory condition

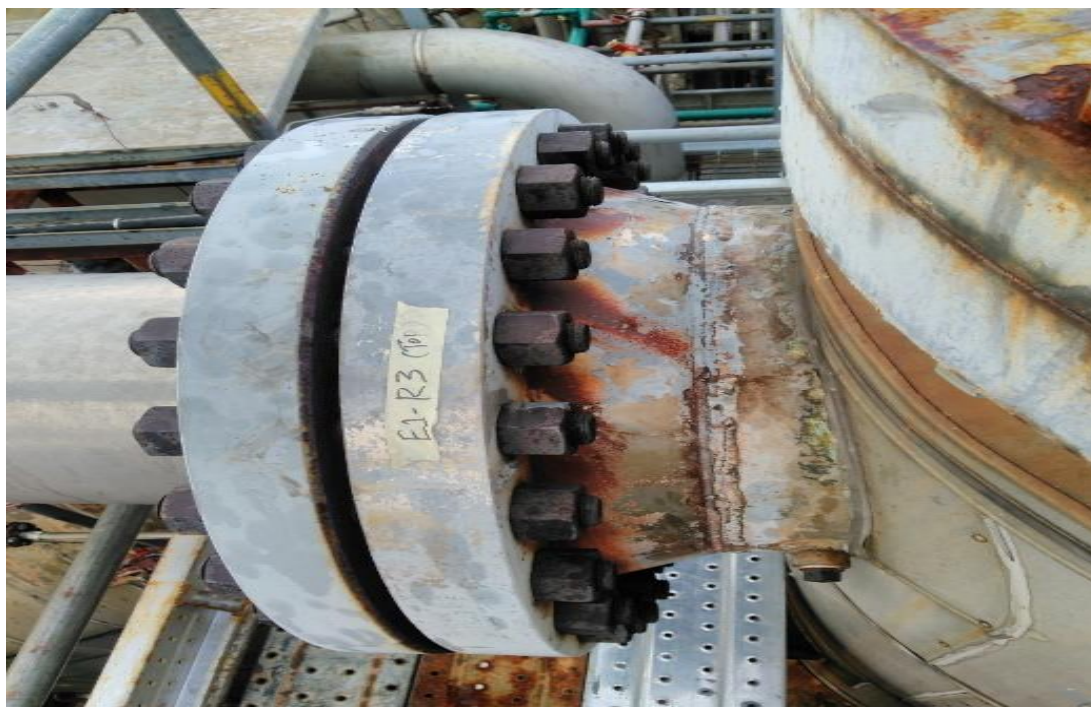
Photo 18: Top area Nozzle was observed in satisfactory condition
