PRESSURE INSPECTION SUMMARY REPORT

API 510 Inspection of Pressure Vessel

E2-R3 OVERHEAD CONDENSER

Report No : LEADS-23-03-API-06 R1

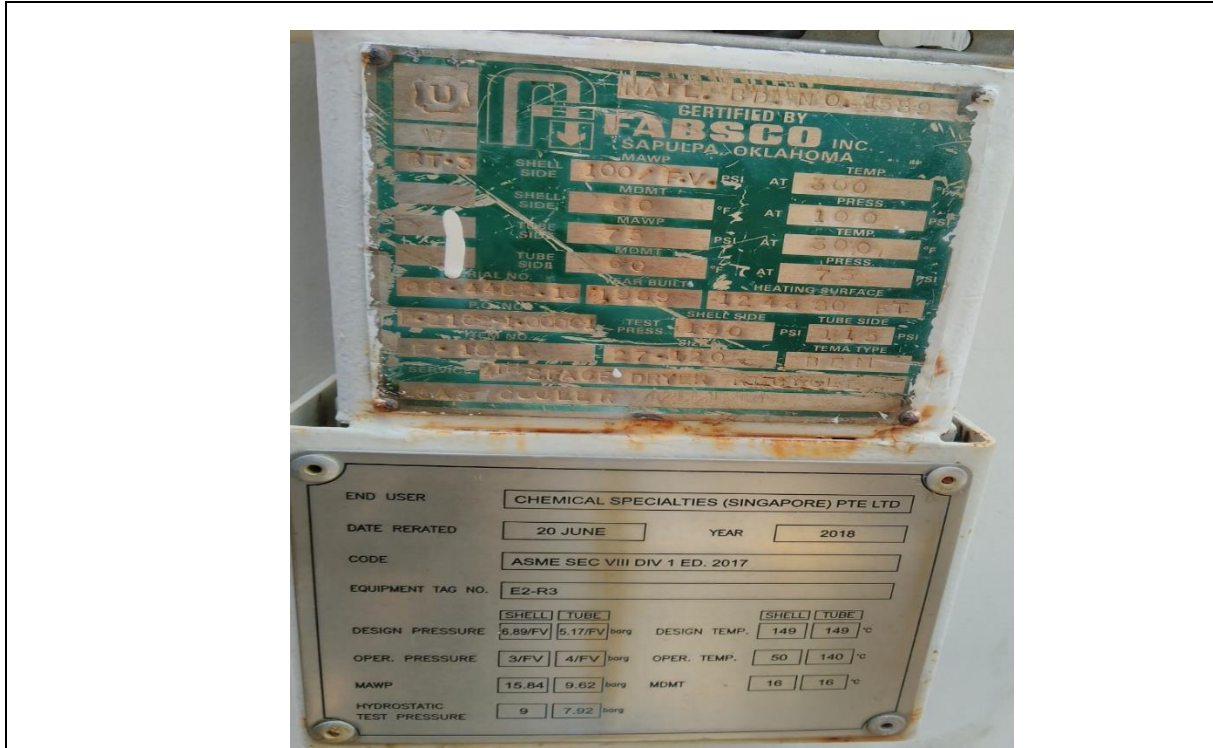
Photo 1: Name plate observed in satisfactory condition.

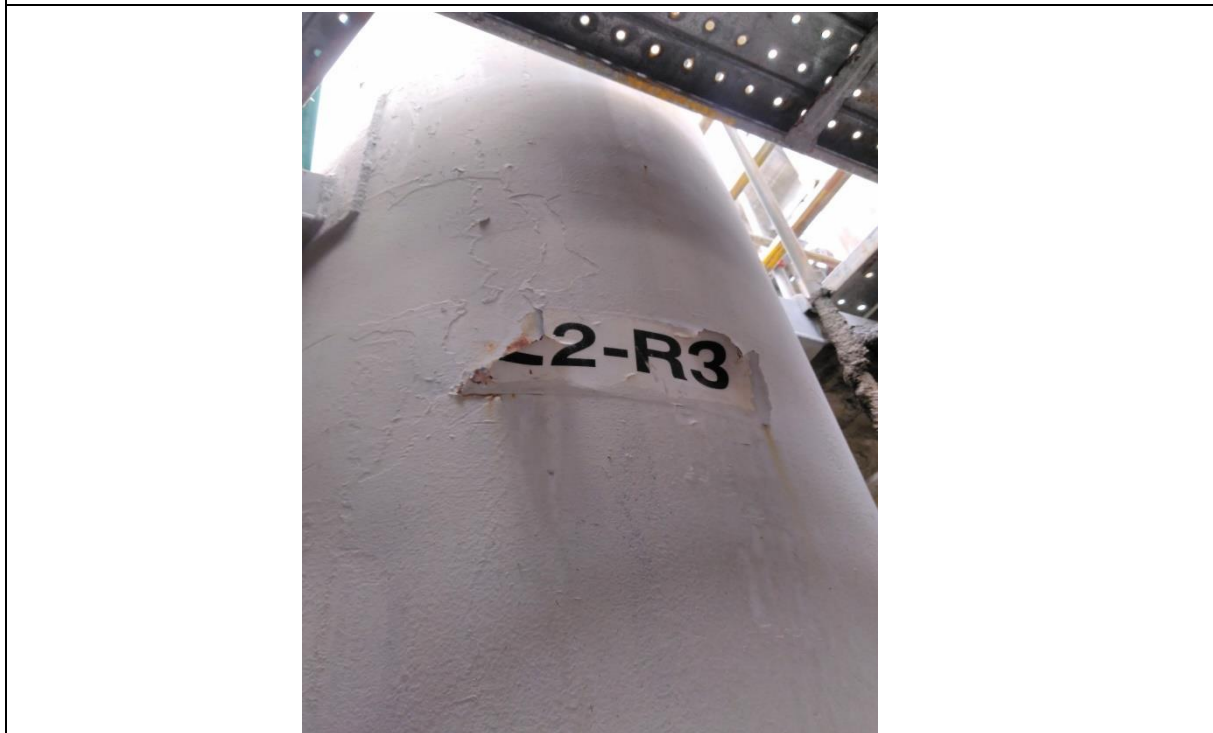
Photo 2: Shell with was observed in Satisfactory condition with coating

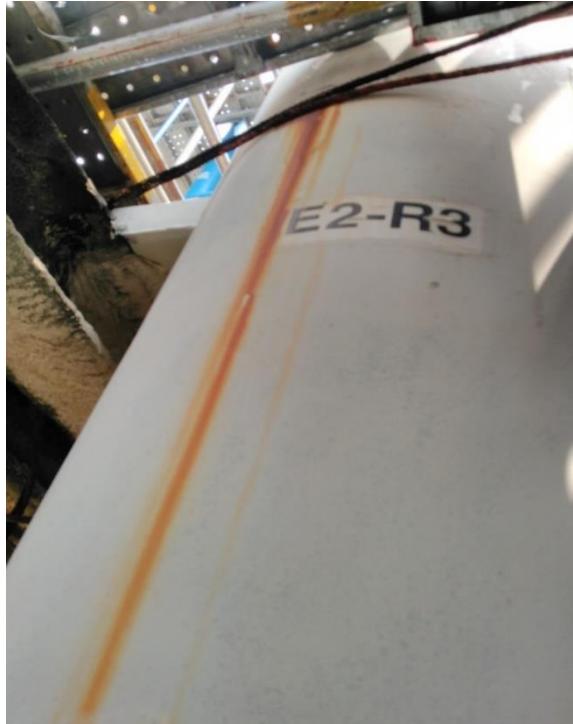
- Generally, in satisfactory condition.
- Minor rusting on shell from the contact with material. Recommend to fix it.

Photo 3: Shell pipe with was observed in Satisfactory condition in general. One location got minor rusting from the material in contact with the shell.

Mandatory Repairs Preceding Return To Service	
I.1	None
Non-Mandatory Recommended Repairs Preceding Return-To-Service	
II.1	None
Future Non-Mandatory Recommended Repairs	
III.1	Minor rusting on shell from the contact with material. Recommend to fix it.
Recurring Maintenance Recommendations	
IV.1	Let the fire and safety systems be checked on an annular base by a safety engineer.
IV.2	Perform proper housekeeping on a regular base.
IV.3	Perform visual and UT inspections as per Inspection Interval Recommendation.

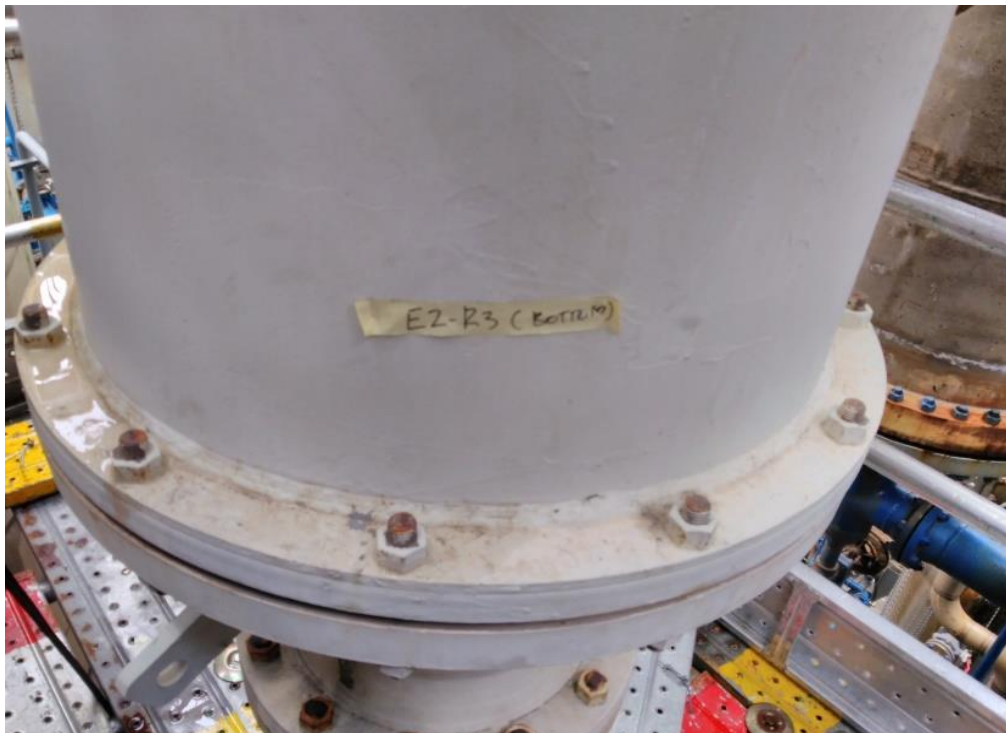
Photo 4: Bottom shell & channel flange joint were in satisfactory condition

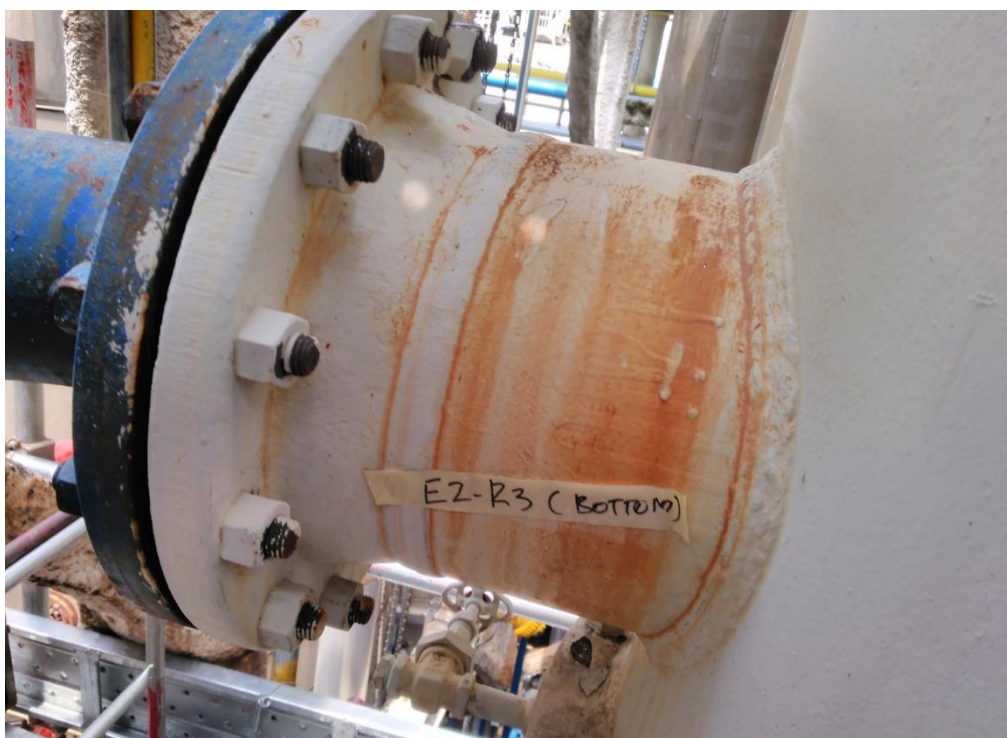
Photo 5: Bottom shell nozzle was in satisfactory condition with rust bleeding

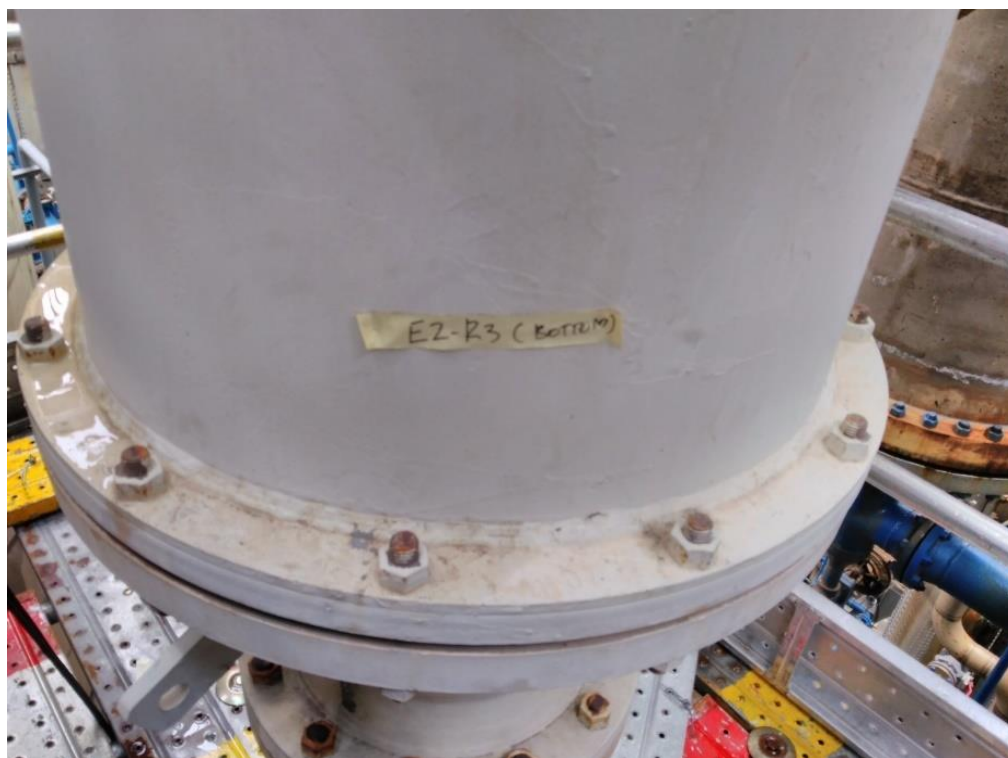
Photo 6: Shell & bottom channel were in satisfactory condition

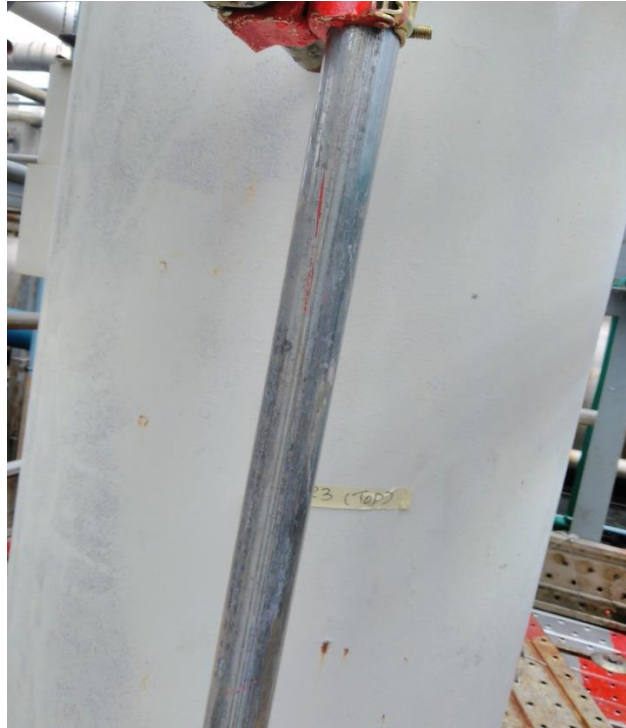
Photo 7: Shell was observed in satisfactory condition

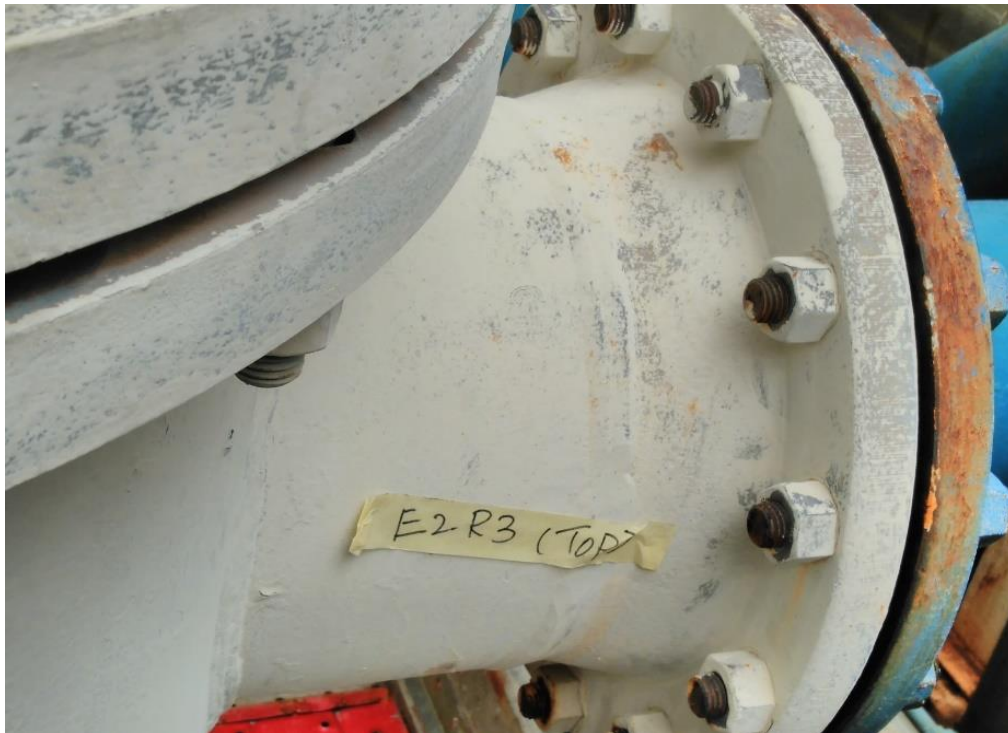
Photo 8: Top shell nozzle was in satisfactory condition

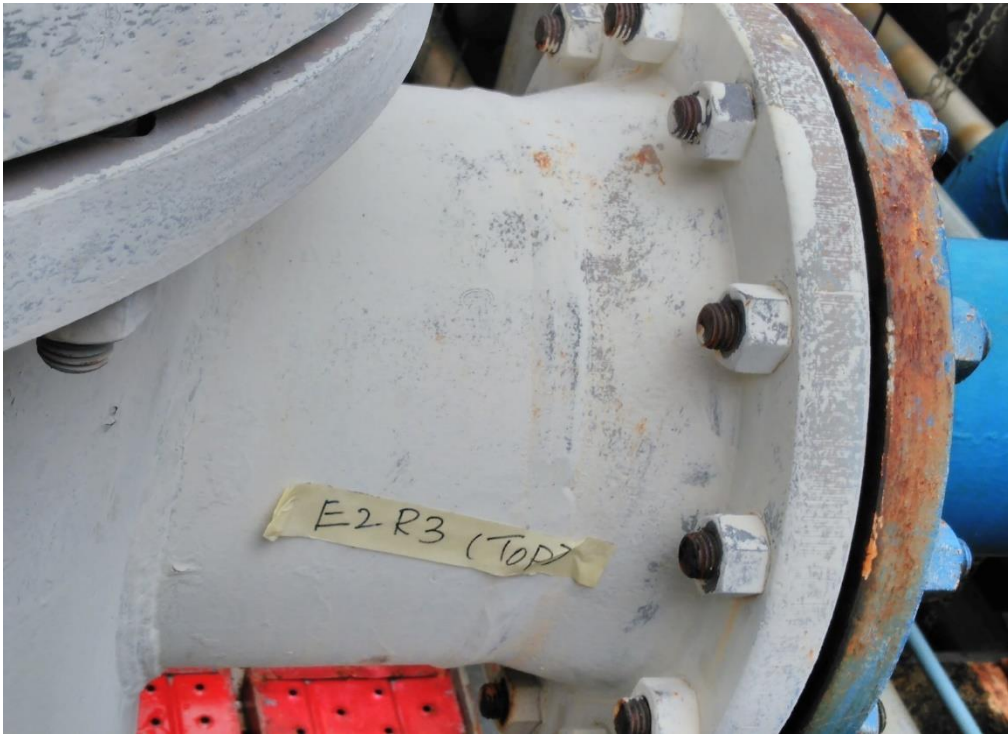
Photo 9: Top shell nozzle was observed in satisfactory condition.
